# Accelerated Corrosion of High Entropy Alloys under Tensile Stress

Aditya Ayyagari<sup>a\*</sup>, Riyadh Salloom<sup>a</sup>, Harpreet Singh Arora<sup>b</sup>, Sundeep Mukherjee<sup>a</sup>

<sup>a</sup> Department of Materials Science and Engineering, University of North Texas, Denton, Texas  
76203, USA

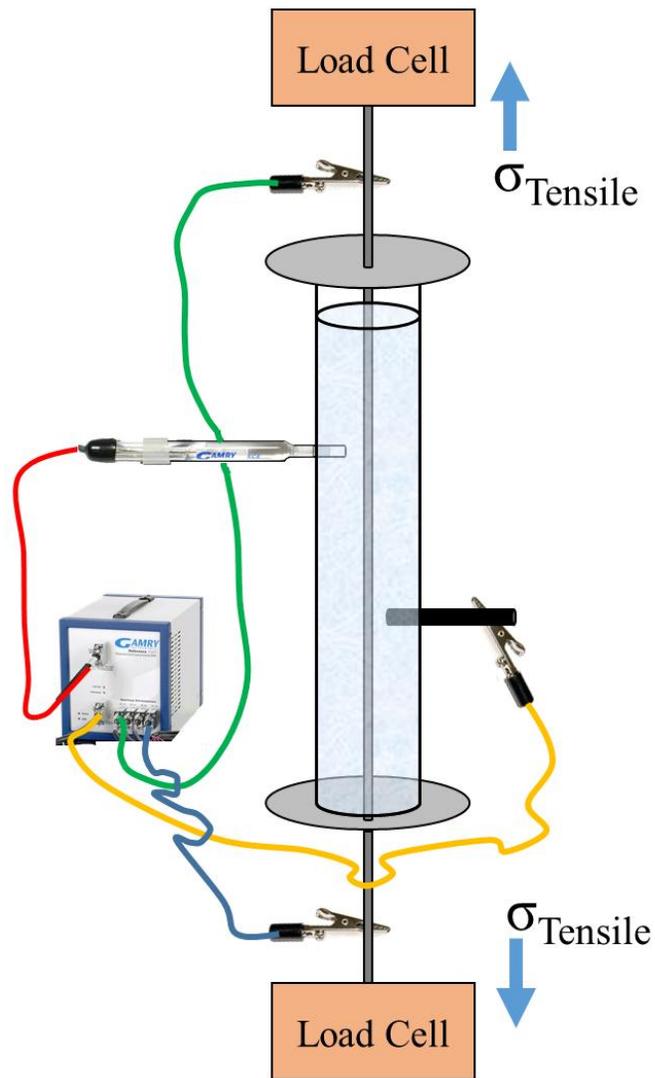
Figure 1: Schematic of SAE module showing HEA cylinder in the center. The rod is connected to Gamry potentiostat. The sample is the working electrode, graphite counter electrode and saturated calomel is the reference electrode.

A schematic of the test set up is shown in Figure 1. Gamry Ref3000 potentiostat in a three electrode configuration was used for measuring the electrochemical response from the sample. A saturated calomel electrode was used as reference electrode, high density graphite as counter electrode and the sample was connected as the working electrode. Uniaxial tensile loading component of the SAE module consisted of ADMET eXpert 4000™ professional tabletop micro tensile testing machine. The two systems were operated by independent standalone computers and respective softwares. The sample in this study ( $Al_{0.1}CoCrFeNi$  alloy) was cast, forged and rod-rolled to 99.7% strain to produce a 2 mm diameter cylinder. The sample was annealed at 1200°C for 20 h to produce a fully recrystallized workpiece. Electron backscattered diffraction (EBSD) of the microstructural-crystallographic characterisation is shown in Figure 2. Figure 2a shows the EBSD map along the wire drawing direction where as Figure 2b shows it normal to the direction of drawing. Despite large plastic deformation, no preferred wire-drawing texture was seen and the microstructure of the rod was highly homogenous and characterized by the equi-axed strain-free grains. The pole figures conforming uniform distribution of grains in the principle crystallographic axes are shown in Figure 2b.

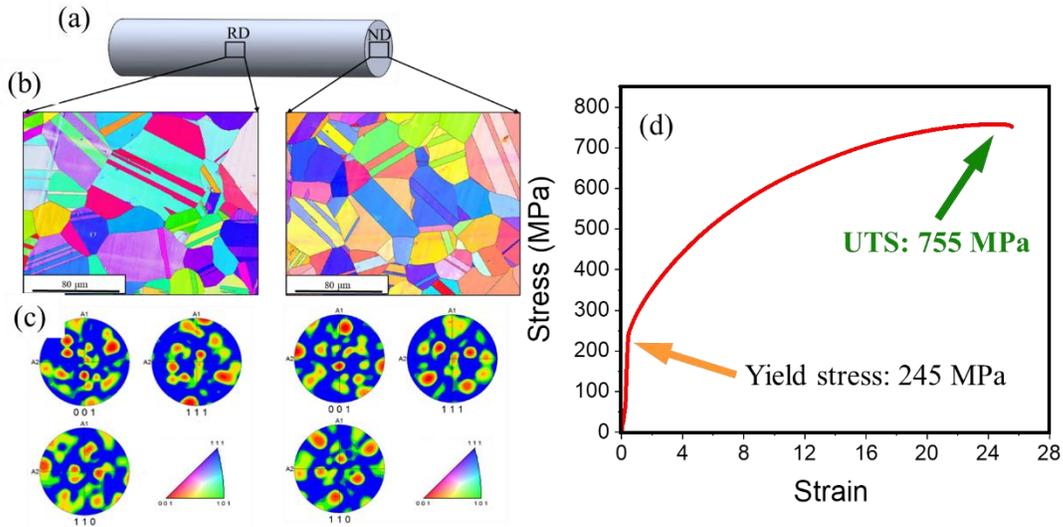
Figure 2: (a) Schematic of the metallic rod showing the rolling and normal directions (b) EBSD images of the HEA cylinder after cold rolling, rod drawing and static recrystallization annealing treatment. (c) pole figures showing distribution of grains in the principle crystallographic axes to be uniform (d) stress strain curve of showing the tensile properties of the samples.

Baseline tensile properties of the wire drawn material were established by performing the tensile test in lab air with a relative humidity of 22%, 24.5 °C, at a strain rate of 0.1 mm per minute. The tensogram of the annealed rod material is shown in supplemental Figure 2c, and the metrics are annotated. The properties of the wire material were identical to bulk cast-wrought material found in the literature [11]. Following baseline measurements, stress accelerated corrosion experiments were carried out by mounting the SAE module onto the tensile testing machine. Fresh set of samples were placed in the fixtures, the electrolytic cell was filled with 3.5 wt% NaCl solution and appropriate connections were made as shown in Figure 1. The sample was allowed to attain stable open circuit potential (OCP) and subsequently swept through a rate of 0.16 mV/s at OCP. The limiting potential for the scan was set as the pitting potential based on observations from previous iterations. The corrosion response of the HEA rod under no external applied stress was recorded as  $E_{corr}^{\sigma=0} = -235 \pm 16 \text{ mV}$  and the  $i_{corr}^{\sigma=0} = 16 \pm 6.5 \text{ nA/cm}^2$  over six iterations. Fresh set of rod samples and electrolyte were used for each experimental iteration. Subsequently, the electrochemical signature while the sample was subjected to uniaxial tensile loading was recorded. Figure 3a shows the stress strain curve of the rod with the SAE module enveloped around it. The dynamic changes occurring in the OCP as the rod deformed are shown

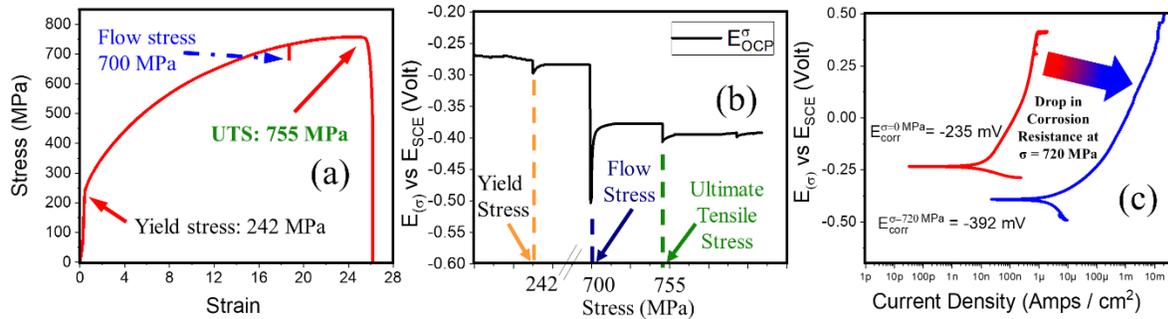
Figure 3: (a) Stress strain curve of the rod with the SAE module enveloped around it. (b) dynamic changes occurring in the OCP as the rod deformed, consisting of transitions between active and passive domains of corrosion (c) potentiodynamic polarization curves showing accelerated corrosion behavior with increased stress

in Figure 3b. The first potential drop of 30 mV was seen at  $E_{OCP}^{\sigma:242} = 299.8 \text{ mV}$  which corresponded to the onset of plastic deformation. The small potential drop was followed by recovery in OCP as the stress continued to increase up to 700 MPa where a sharp drop of 225 mV ( $E_{OCP}^{\sigma:700} = -500 \text{ mV}$ ) was observed. This was immediately followed by a second potential recovery regime during which the OCP remained stable at -400 mV. The sample was stressed up to the ultimate tensile limit of 755 MPa at which third significant potential drop of 37 mV was recorded in the potentiogram. The OCP at UTS was  $E_{OCP}^{\sigma:755} = -392 \text{ mV}$  with a cumulative drop of 125 mV as compared to the pristine rod. The tensile loading was paused at UTS and the sample was subjected to a potential sweep to record the corrosion current density and corrosion potential. The corrosion response is shown in Figure 3c. The  $i_{corr}^{\sigma:755} = 4.7 \pm 0.65 \mu\text{A}/\text{cm}^2$  with a slope of the anodic branch of the potentiogram slightly tending towards active corrosion. The electrochemical test was terminated at current density of  $\sim 10 \text{ mA}/\text{cm}^2$ .

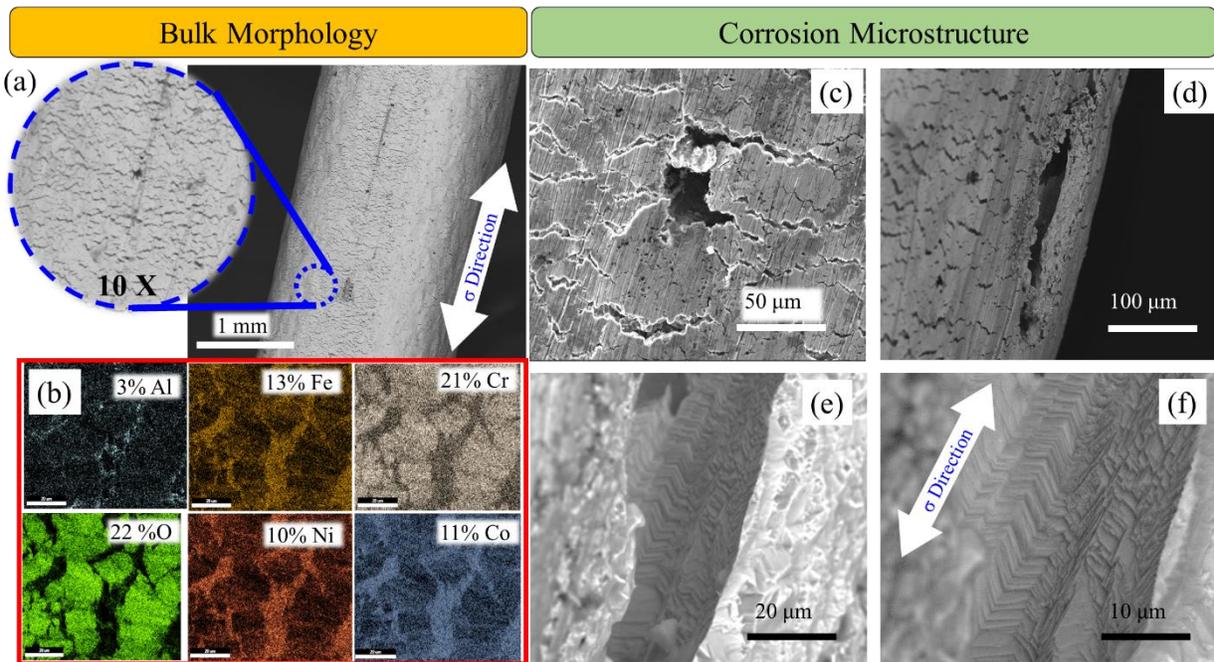
Figure 4: (a) Corrosion morphologies on the HEA surface showing oxide cracking; (b) EDS images show discontinuity of oxide regions and exposure of underlying metallic substrate (c) corrosion pits growing due to the coalescence of surface cracks (d) large surface crack (e) morphology of cracks propagating in the loading direction along the edges of slip planes (f) high magnification image of corroded slip planes.

Figure 4a shows the surface of the rod after corrosion experiments recorded in FEI-Quanta environmental scanning electron microscope. The sample was observed to have multiple cracks normal to the loading direction as shown in the magnified inset. Figure 4b shows surface cracks and consequent exposure of underlying base metal, akin to characteristic mud-cracking appearance. Elemental scans performed using inbuilt energy dispersive x-ray spectrometer showed that the surface oxide had cracked, exposing the underlying material to electrolyte and consequent accelerated corrosion during the a potential sweep in Figure 3c. No distinct necking was noticed as the rod. The potential drops observed during OCP scan may have their origins in the surface oxide cracking. Sudden supply of electrons from the pristine material exposed due to surface oxide cracking may have resulted in drop in  $E_{corr}$ . This magnitude of potential drop was small at yield stress ( $\sim 4\%$  strain) where deformation was low, consequently having lower number of active sites that initiated corrosion. At flow-stress, (defined as a stress higher than the yielding point, but lower than fracture) the elongation was  $\sim 16\%$  that likely resulted in exposure of a large fraction of unpassivated surfaces which explains the large drop in the  $E_{corr}$ . This observation was consistent with multiple iterations of the experiment indicating that there may be a critical stress value between yield and tensile strengths at which rate of nucleation of deformation induced surface cracking is highest, and consequent accelerated corrosion. The recovery in OCP towards nobler value after sharp drops at yield, flow and ultimate tensile stresses may be due to the attainment of equilibrium with the electrolyte. Although there is recovery in the potential,

High magnification SEM images of the corroded regions are shown in Figure 4c. Surface-oxide breakage and corrosion penetration from the unpassivated surface is shown in Figure 4d. It is observed that the kinetics of corrosion propagation is higher at the surface cracks tips, owing to the high stress concentration. The propagating crack tips coalesce and form corrosion pits as shown in Figure 5c. A high magnification image of a large pit (Figure 4d) is shown in Figure 4e. Corrosion appears to propagate via a stepped morphology and preferentially along the loading direction. The direction of stress application of stress and resulting slip lines are clearly visible in the zoomed-in image Figure 4f. These slip planes and sharp boundaries indicate that preferred sites for corrosion nucleate along deformation bands akin to twins and grain boundaries in metallographic etching.
